## Adonyi Welding Consultants

**Subject: X60 welded pipe field failure**

A piece of API X60 pipe 12.75" OD and 0.219" wall thickness was received for evaluation and root cause analysis for failure during hydrotesting.

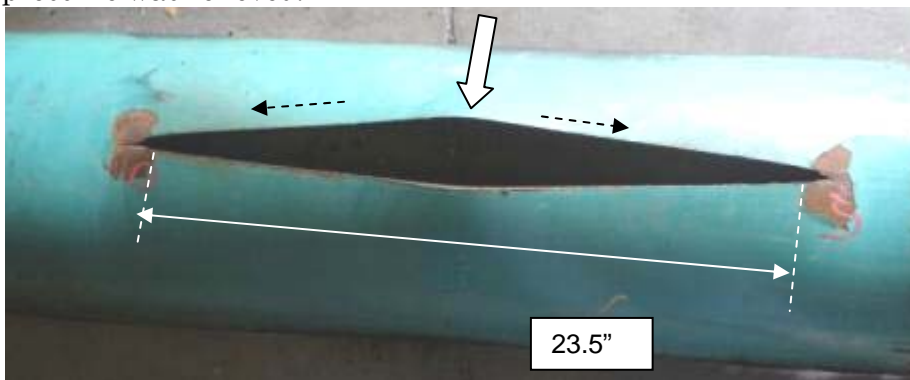
A top view of the failed pipe is shown in Figure 1, showing evidence of classical fracture under Hoop stresses, initiating at the middle (Arrow), propagating in both direction (dashed line) and stopping when the driving force i.e, the internal pressure was relieved.

Figure 1. Top view of the pipe fractured during hydrotesting along the ERW weld line. The total crack length ( $2a=23.5''$ ) can be used in calculation of strain energy release, assuming a classical Griffith plane strain model).

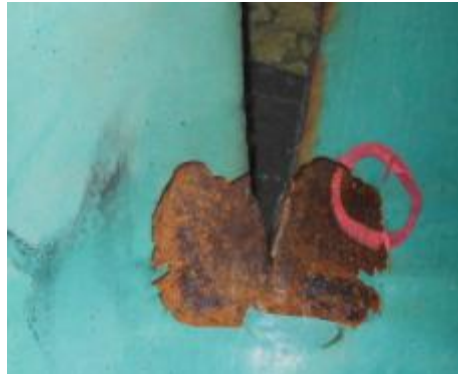
Figure 2 shows one of the extremities of the fracture where the crack propagating along the ERW centerline stopped.

Figure 2. Crack arrest side O, with the paint peeled off around the plastic zone in front of the crack tip. This is typical of a classic Case I situation in Fracture Mechanics when the stress in front of the crack tip becomes lower than the yield strength, causing the crack to stop.

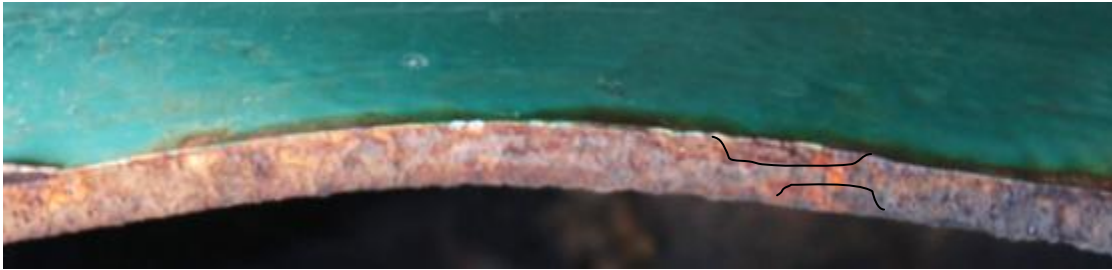
Figure 3. Multiple potential initiation/propagation sites on the weld ID and OD sides of the weld. Chevron marks on the fracture surface indicate sudden crack propagation in a single-event failure.

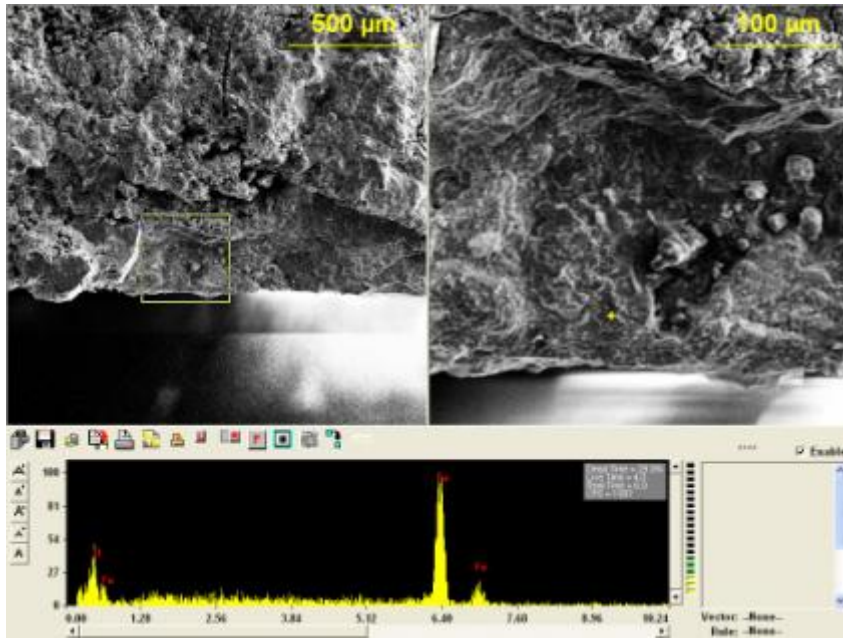
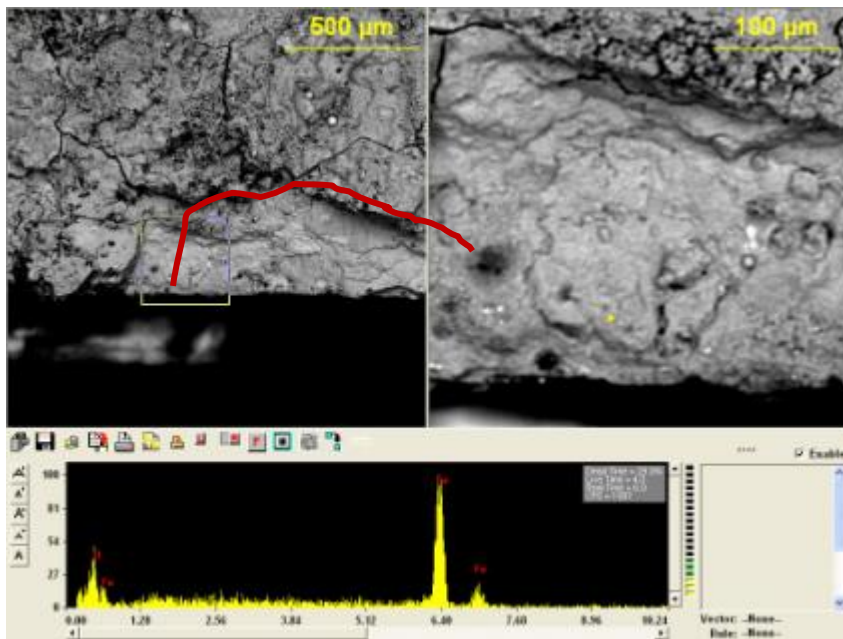
A close-up of some possible initiation sites were highlighted and sized relative to the wall thickness. One of the ID weld lack of fusion is shown in Figure 4.

Figure 4. Secondary Electron (a) and Backscattered Electron Imaging (b) of the ID initiation site – highlighted – covered with heavy Iron Oxide

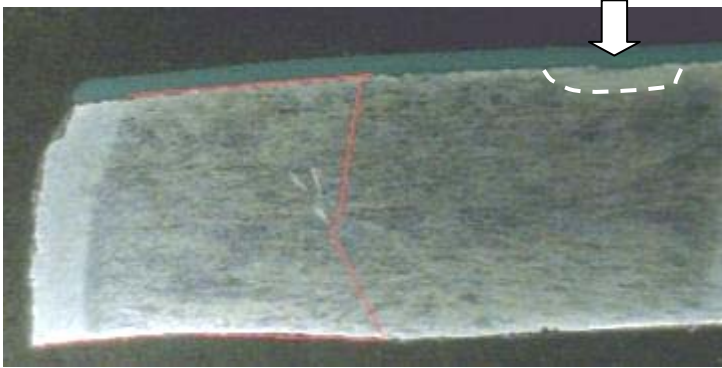
Calculating the Hoop tensile stresses for the 1,750 psi at failure resulted in a stress of 54.71 ksi, which is less than the 69 ksi yield strength of the steel ( $\sigma = [P \cdot r] / t$ ). Therefore, a discontinuity had to be present to lower the strength of the

pipe wall. Indeed, the longitudinal ERW weld split along its centerline and several discontinuities were apparent at the initiation site, together with evidence of plastic deformation as well as thinning of the pipe wall due to excessive weld scarfing, Figure 5.

Figure 5. Transverse cross section through the initiation site, showing that the fracture occurred along the weld centerline, as well as evidence of thinning (see highlighted area 2.6 mm wide), 8.7 X magnification.

1. Improve ID scarfing to avoid reducing the thickness in the weld area and eliminate gouges that act as stress risers. I believe NDE and metallography at the mill should have caught this problem after manufacturing.
2. Improve the NDE technique sensitivity, as the UT system should have certainly been caught during post-weld inspection
3. Improve High Frequency welding parameters to avoid internal inclusions in the future (better squeezout, improved welding cleanliness, etc).

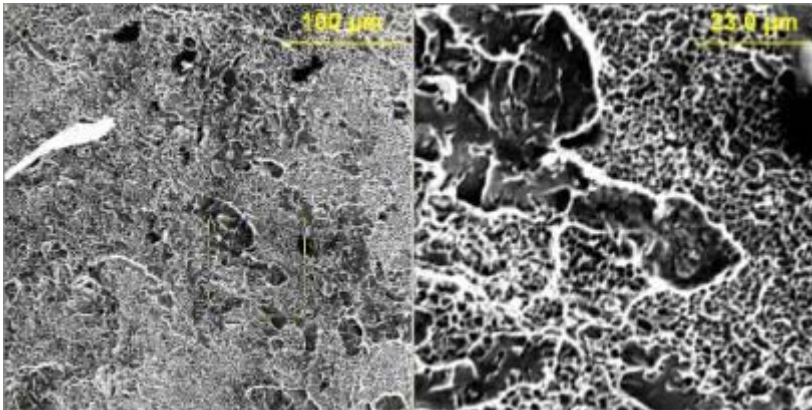
For this initial plastic deformation to occur (probably during the first 10 minutes of hydro-testing, as reported), the local stress must have exceeded the yield strength of the material (69 ksi). Evidence of plasticity was also found on the fracture surface, Figure 6, further supporting the initial yielding theory before the final sudden fracture.

Figure 6. Ductile dimples on the fracture surface, ID toward mid-section area, confirming initial plasticity and deformation in the pipe, 1000 X magnification

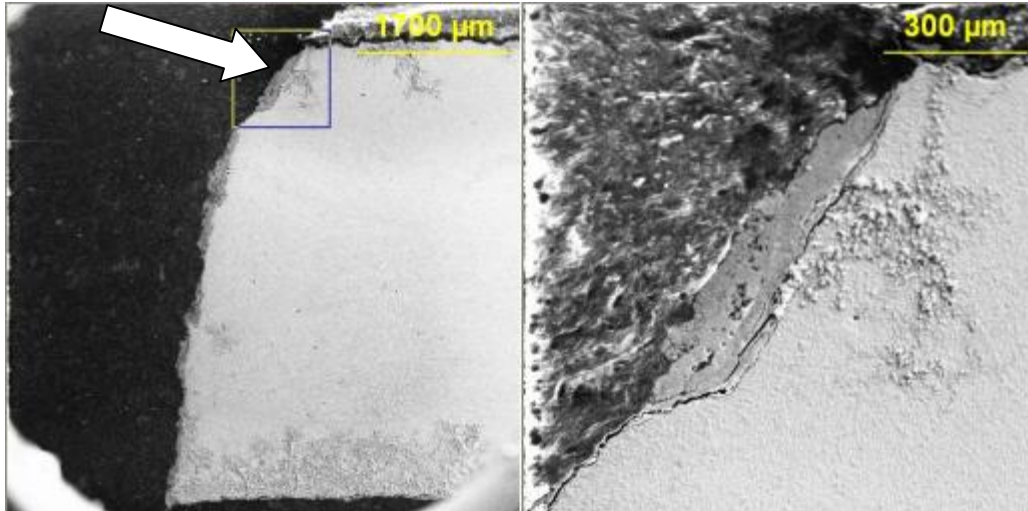
Figure 7. Close-up of the OD weld centerline oxide inclusion (arrow) that reduced the effective cross section resisting deformation, 90X magnification.

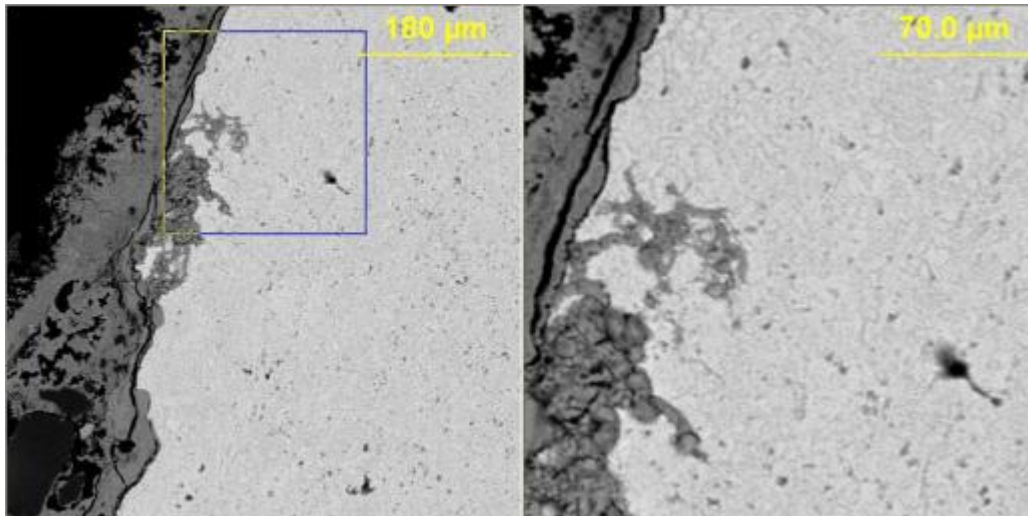
Figure 8. Morphology of the entrapped oxide at the weld centerline, 370 X magnification

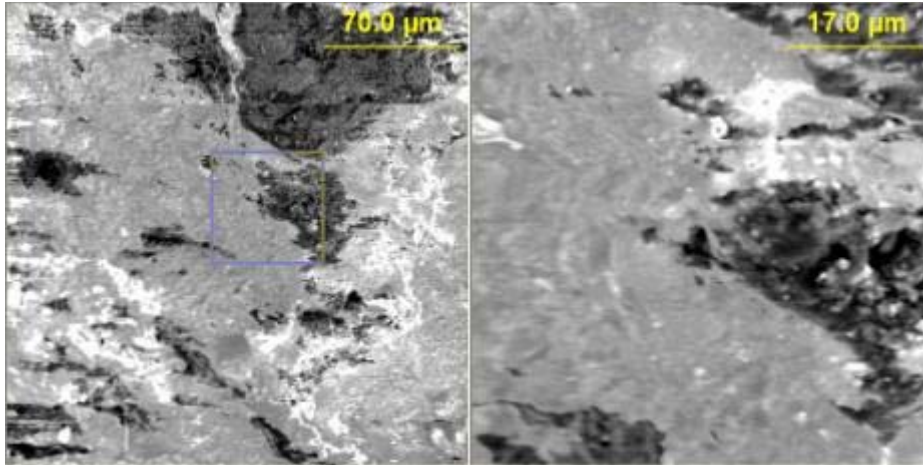
Figure 9. SEM view of the high temperature oxide on the fracture surface at the initiation site. Again, the flat surface of the entrapped oxide was likely the lack of fusion that initiated the final failure. These areas correspond to the top (OD side) of the cross section shown in Figure 5.

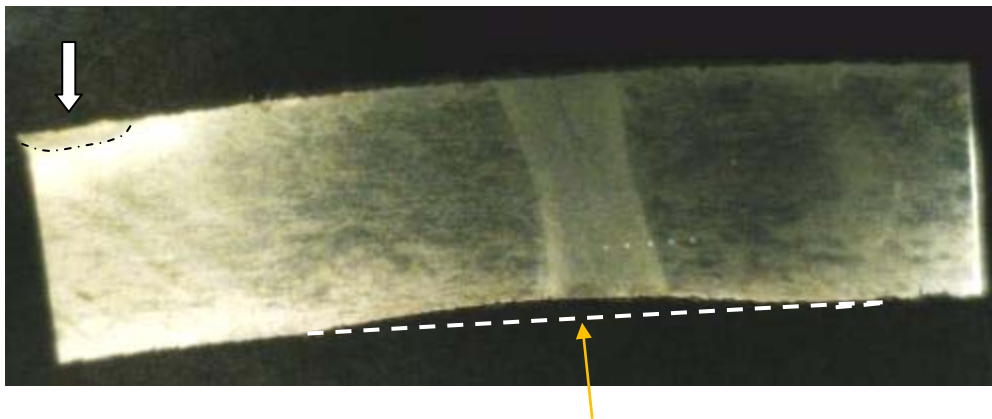
Finally, a random cross section was performed on the ERW weld away from the fracture site, Figure 10.

Figure 10. View of the ERW weld ~ 2 feet away from the failure area, 8.3 X magnification. Notice the excessive and asymmetrical ID scarfing that caused wall thinning of 0.6 mm or 9%, as well as the arc mark from the sliding contact, arrow, 2.35 mm wide arcing HAZ.

It is unclear what kind of weld parameter fluctuation produced the narrower arcing HAZ than in the area of the initiation site. Nevertheless, a tighter parameter control will be required in the future, including elimination of HAZ and sliding contact arcing.

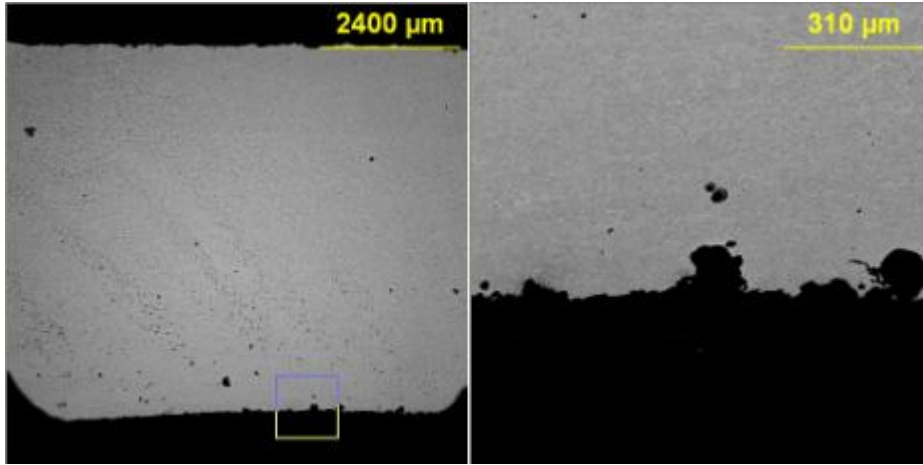
A close-up at ID weld centerline revealed in cross section additional grooves (stress risers) left by inadequate scarfing, Figure 11, as well as a centerline inclusion line shown in Figure 12.

Figure 11. Longitudinal grooves left on the weld ID side by inadequate scarfing, possible initiation sites for failure under internal pressure because of stress concentration

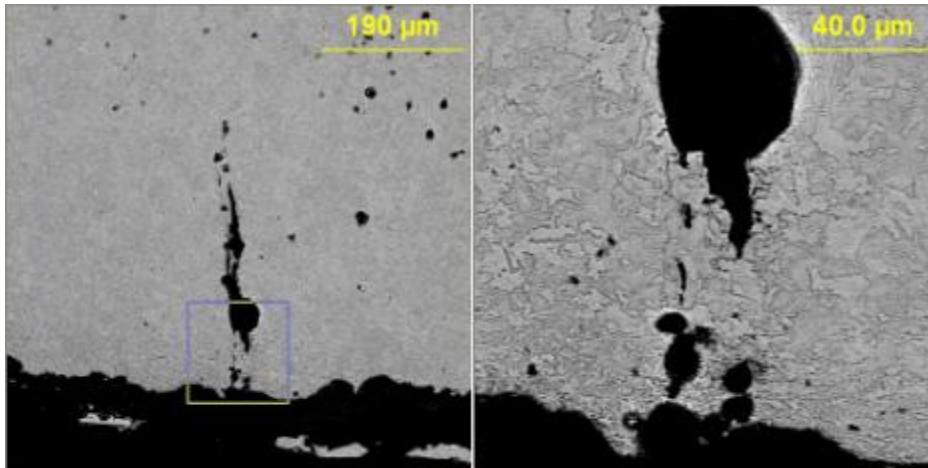
Figure 12. Internal lack of fusion along the weld centerline, the most likely cause for failure initiation, as shown in the fractograph in Figure 4.
